Development of Test Methods for, and the Evaluation of, Miles Transducers

John D. Ramboz

Engineering Mechanics Section, Mechanics Division
Institute for Basic Standards
National Bureau of Standards
Washington, D. C. 20234

June 1976

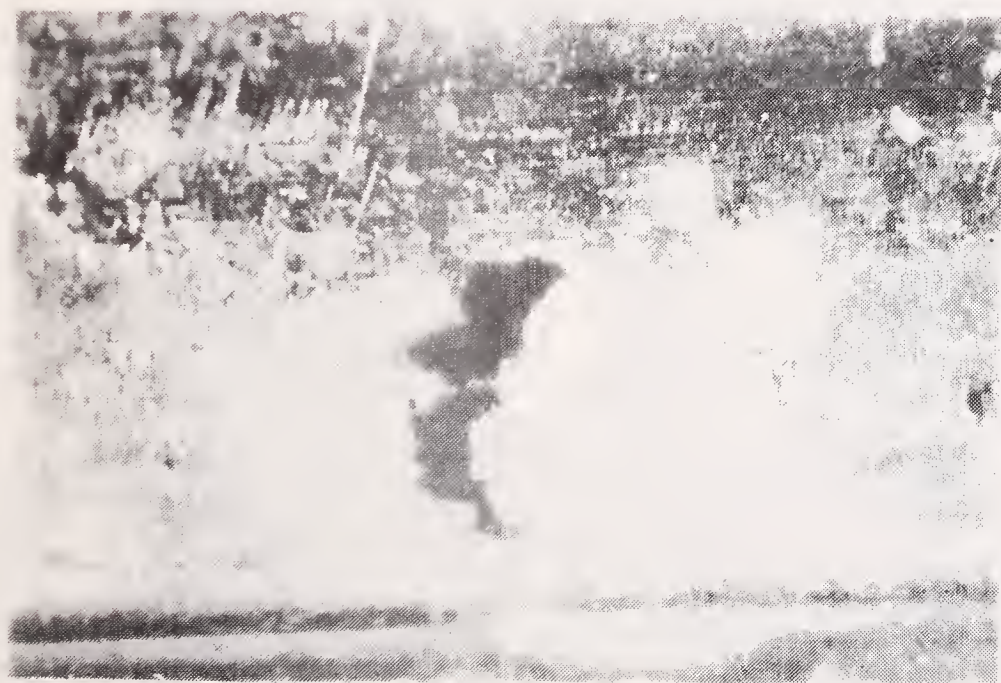
Figure 10. "Salt domes", front lip of transducer 7B, location 47 (20x magnification).

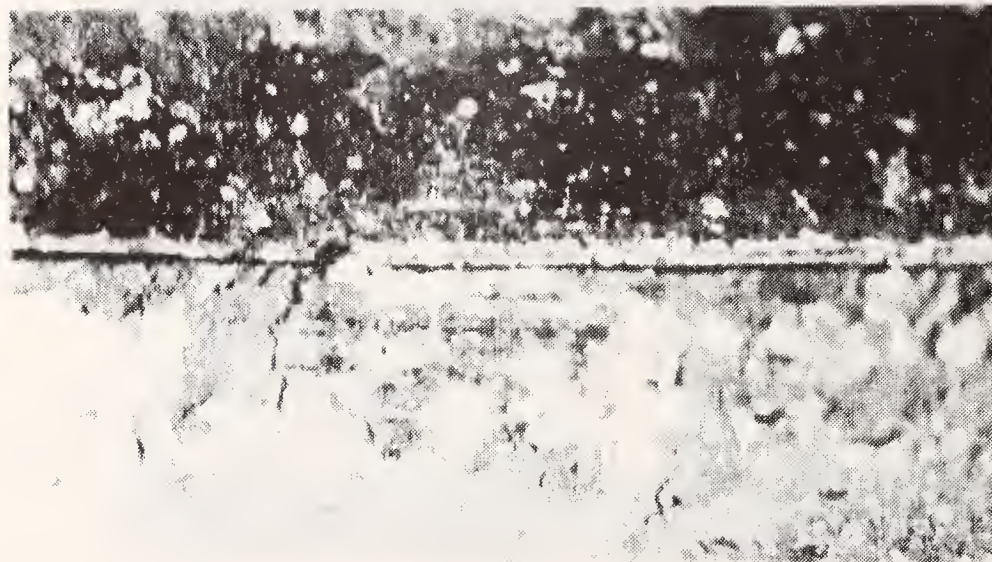
Figure 11. Severe pit corrosion at lip crevice, transducer 7B, location 47. Salt shown in Fig. 6 washed clear (80x magnification).

Figures 11 and 12 show pits which penetrated. The corrosion shown in Figure 11 began in the crevice at the edge of the overlapped lip in the weld zone. In a length of about 400 μm , there were several pits which penetrated. Also note that the upper lip of the lap was corroded in a semicircular shape. Figure 6 shows this same region prior to removal of the salt, at somewhat less magnification. Figure 12 shows a cell which had a long slender track of corrosive activity. It had also penetrated the sheath. These illustrate typical corrosive pits found in the sheaths of the transducers.

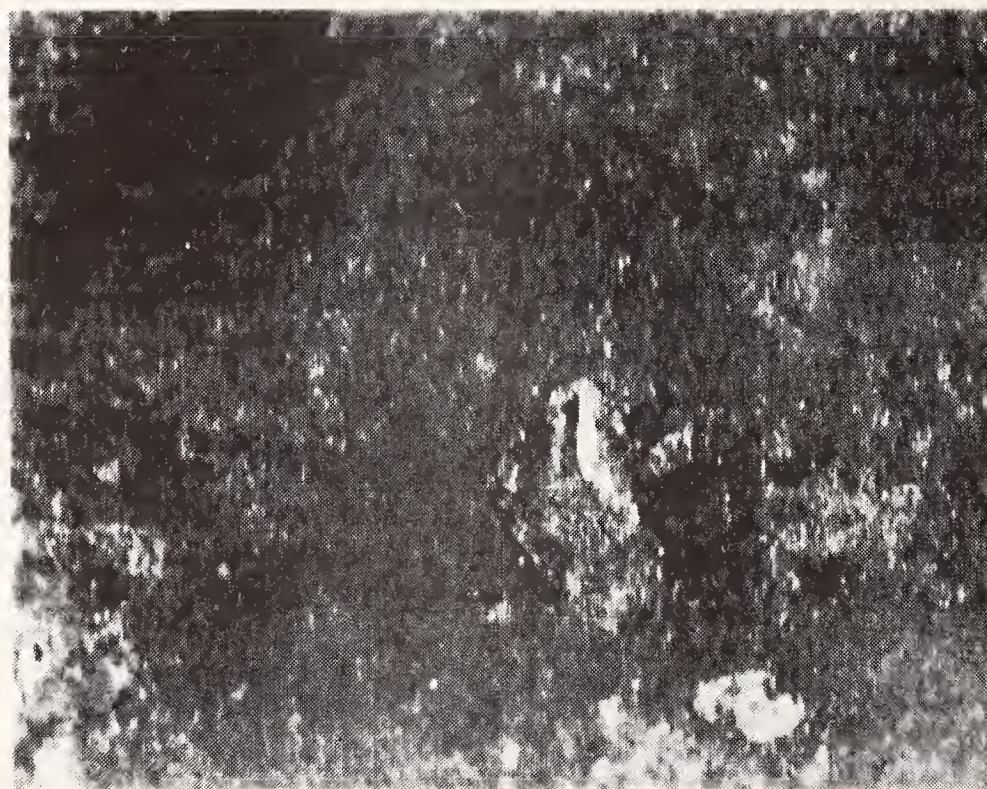
Figure 12. Small elongated pit which penetrated transducer 7B, location 74, back lip. Salt shown in Fig. 7 washed clear (80x magnification).

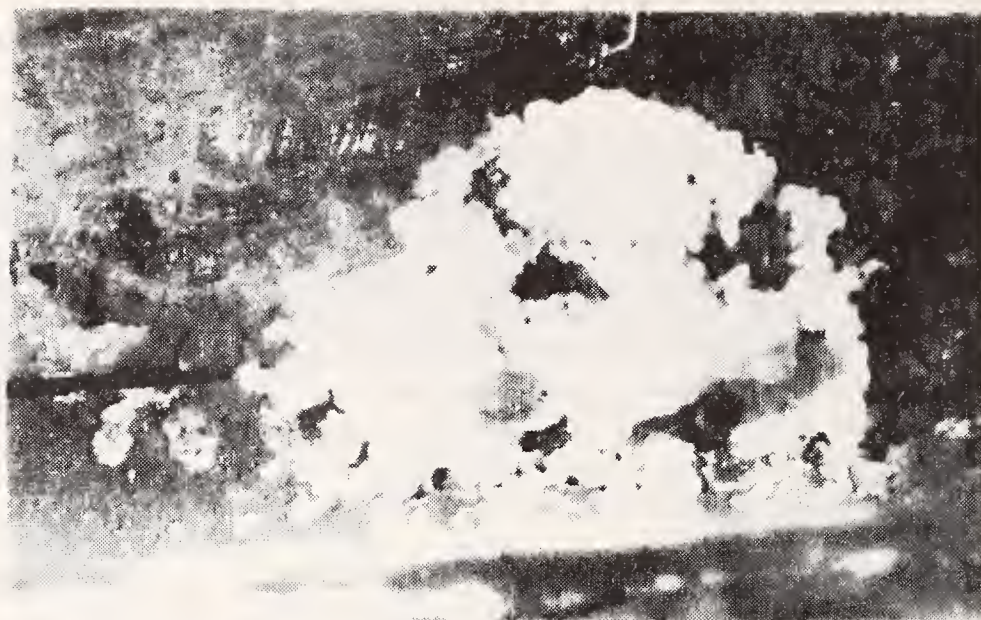
Figure 6. Dried "salt dome" on flat transducer 7B, location 47, at edge of overlapped weld zone.

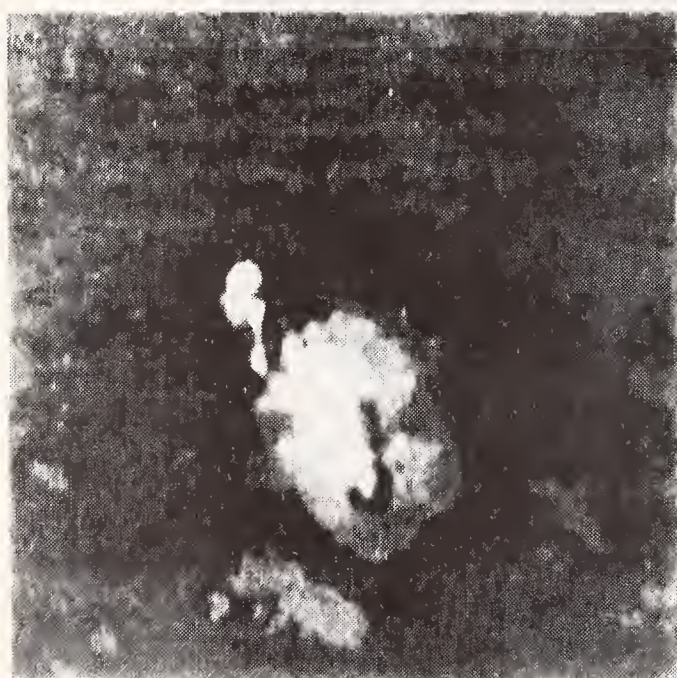
Figure 7. Small "salt domes" on flat transducer 7B, location 74, on back lip (40x magnification).

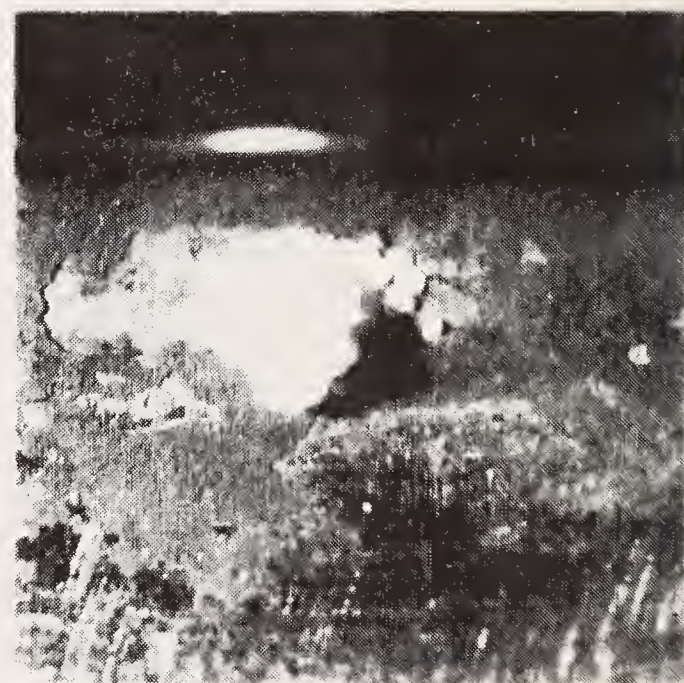
Figure 8. Small "salt dome", front lip of transducer 7B, location 47 (20x magnification).

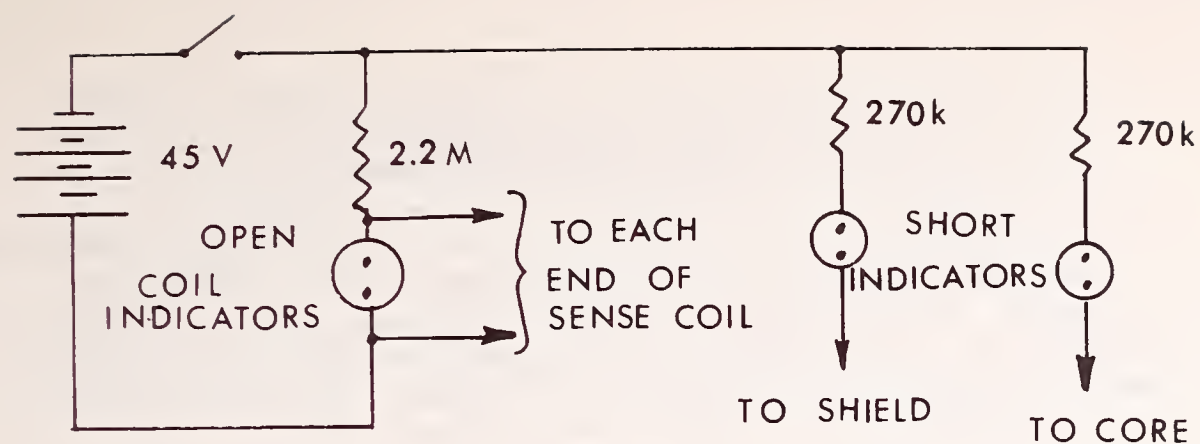
Figure 13. Simple indicator used in rock damage tests for detecting open coil or short between shield and coil or coil and core.

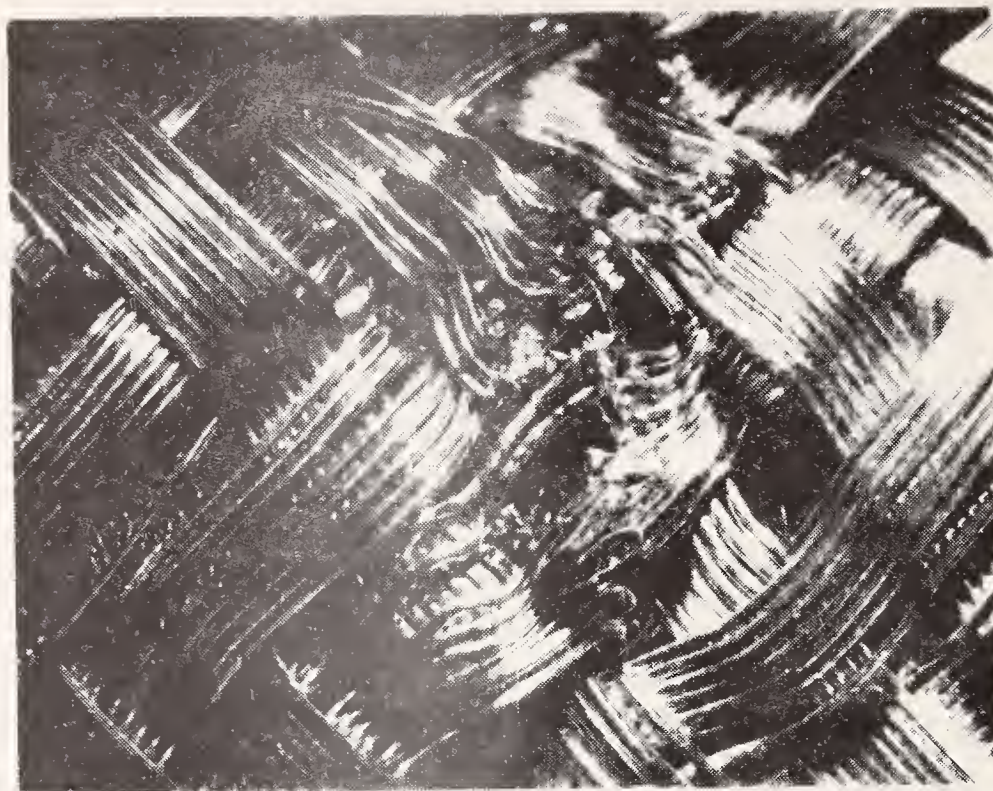
Figure 14. Damaged braid shield of round transducer specimen No. 52 after a 100-hour exposure at a 375-lbf load.

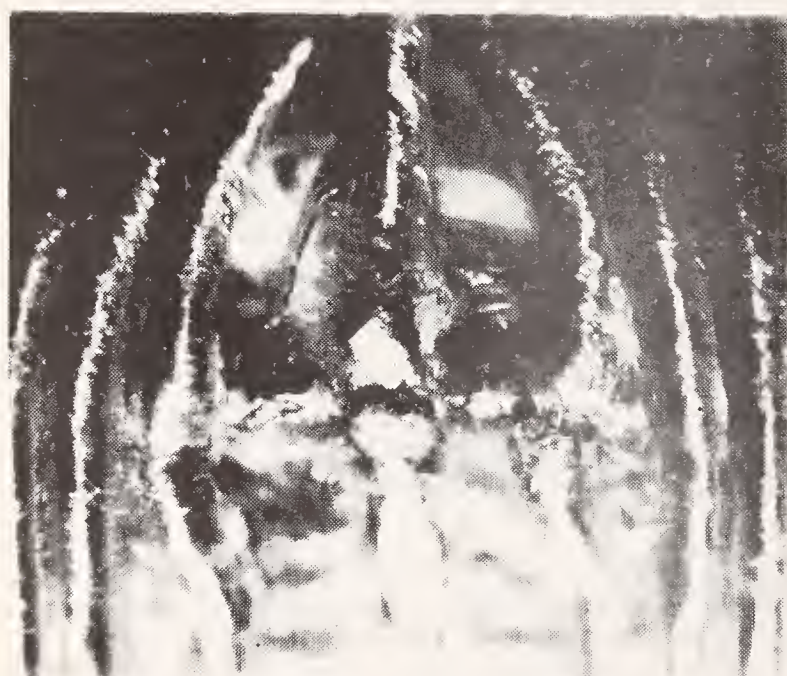
Figure 15. An open sense-coil winding of round transducer specimen No. 37.

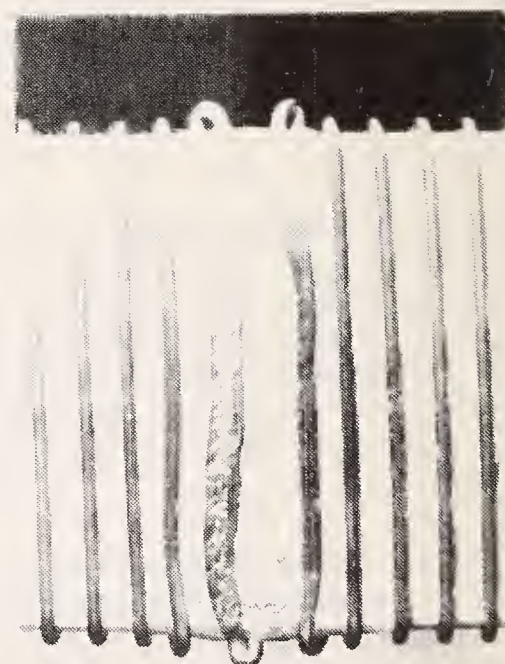
Figure 16. The sense-coil winding of flat transducer specimen No. 71 after a 100-hour exposure at a 2043-lbf load.

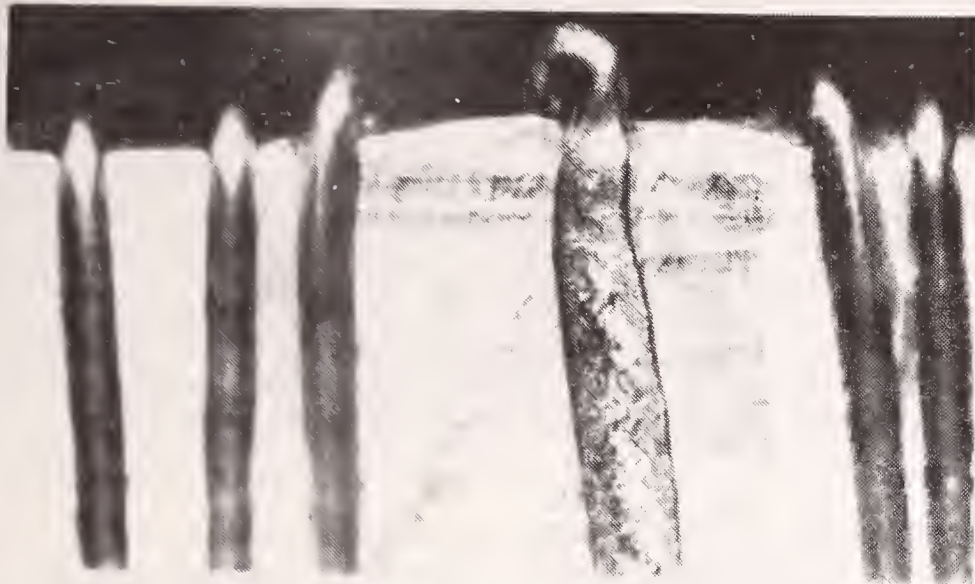
Figure 17. Smashed sense coil for flat transducer specimen No. 71 after an exposure of 100 hours at a 2043-lbf load.

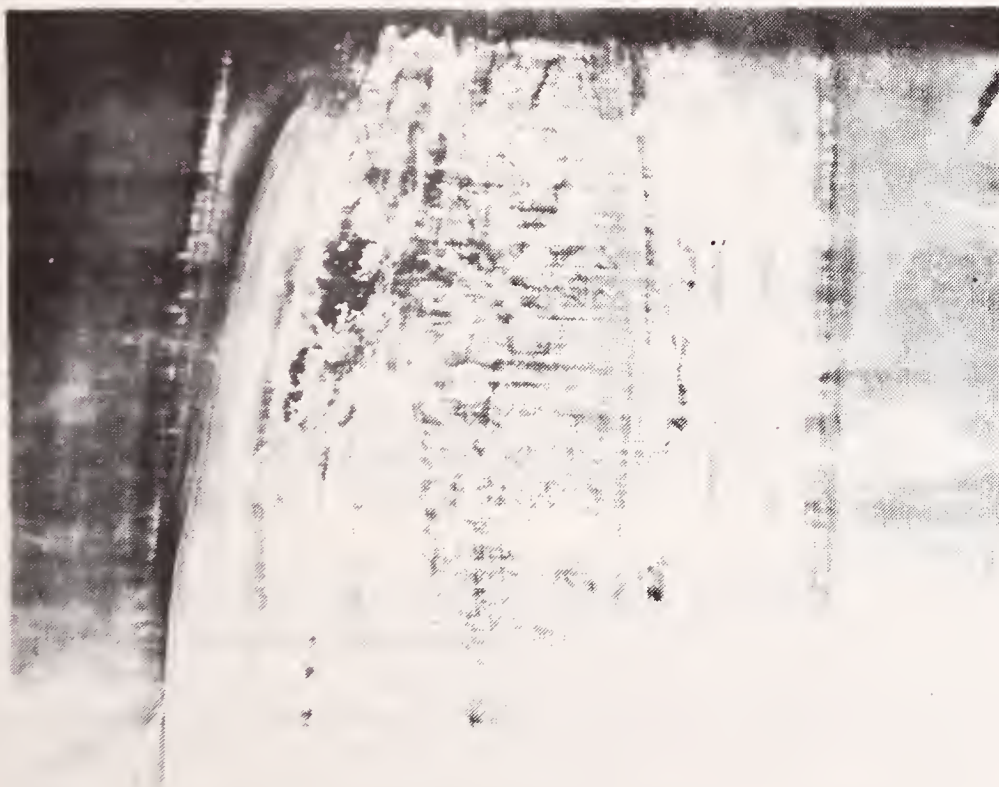
Figure 18. Damaged polyester tape insulation on flat transducer specimen No. 72. Note holes exposing core material beneath insulation.

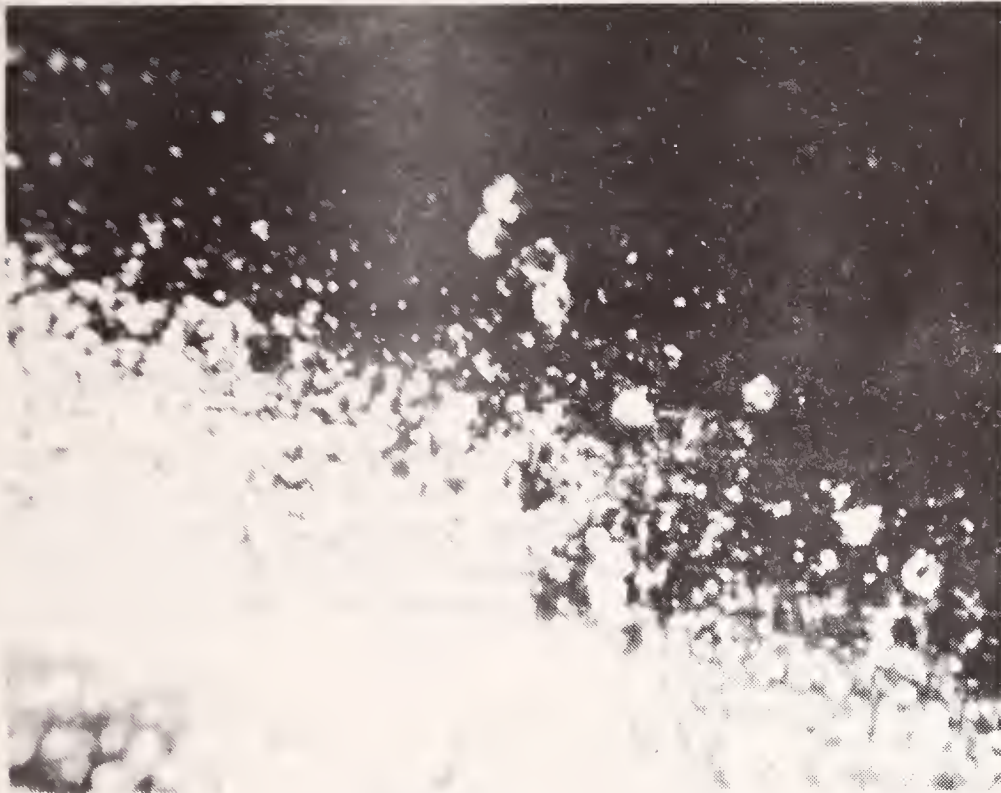
Figure 19. A field of small pits observed on transducer MILES 96R-1 at Griffis Air Force Base. Pit diameters are approximately 0.04 to 0.09 mm (1.5 to 3.4×10^{-3} in).

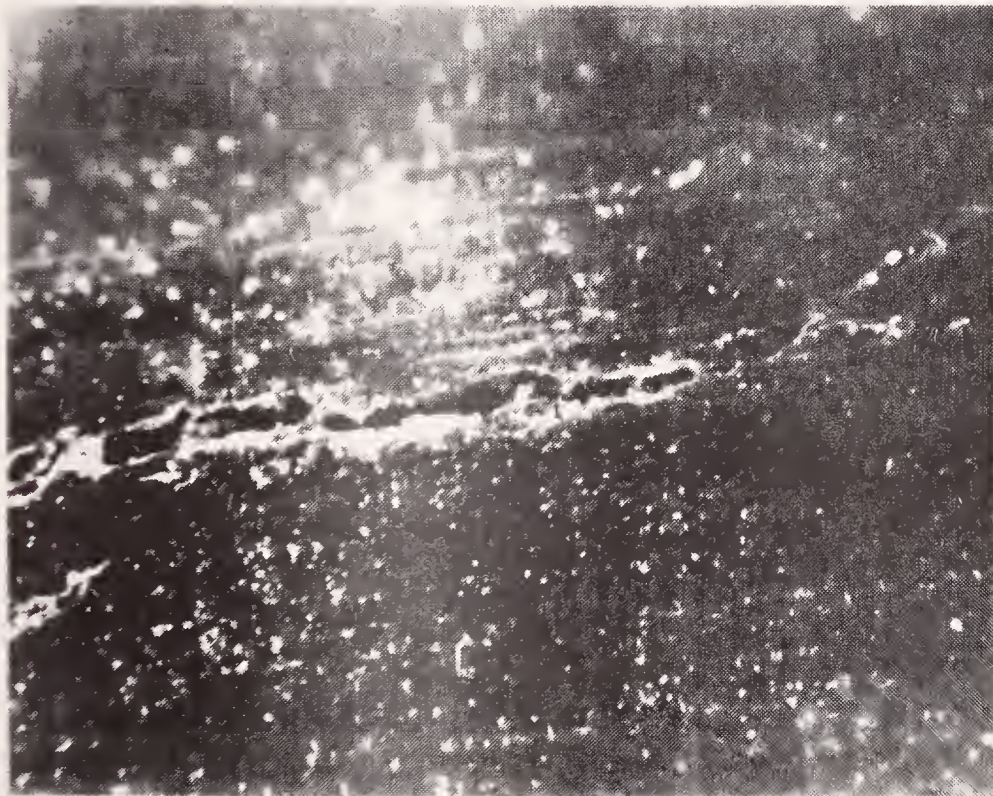
Figure 20. Large crack in the polyurethane jacket of transducer MILES 96R-1 located at Griffis Air Force Base.

1.1 mm (0.045 in) thick. The origin of this crack is not known, but it constitutes a near failure of this particular transducer. Only one such crack was discovered in the several-meter length examined.

³⁰ The large crack is located approximately 152 cm (60 in) from the cylindrical boot near the cable end of the transducer.

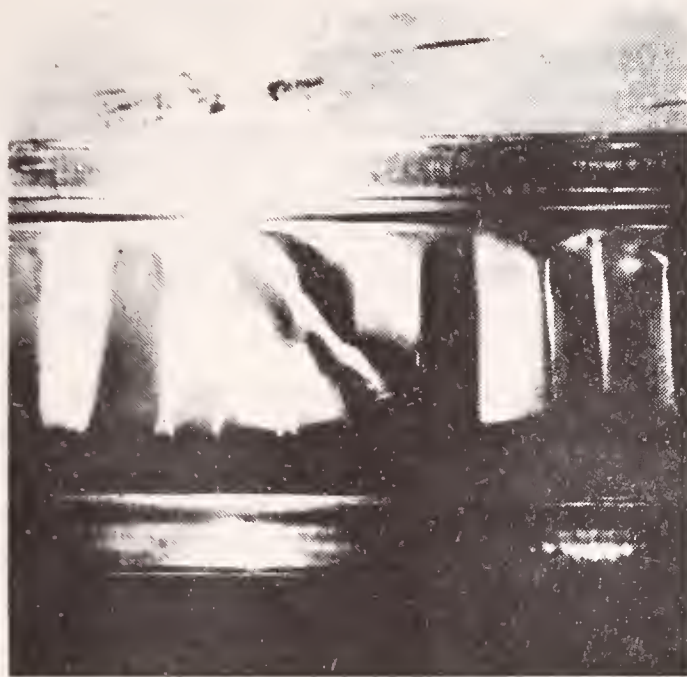
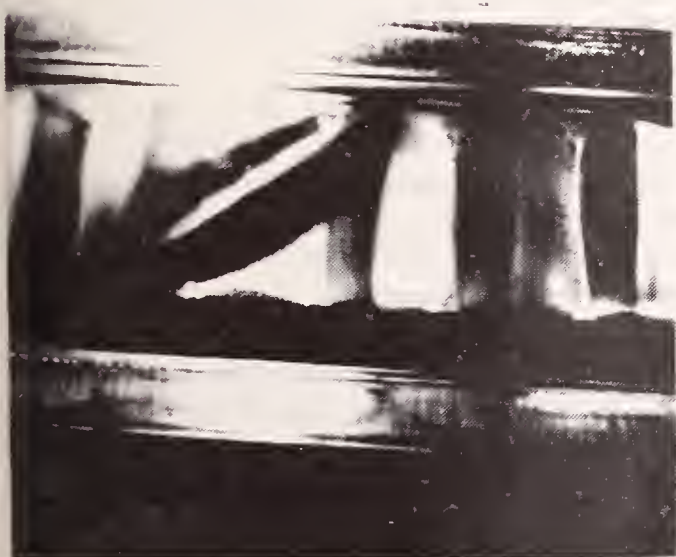
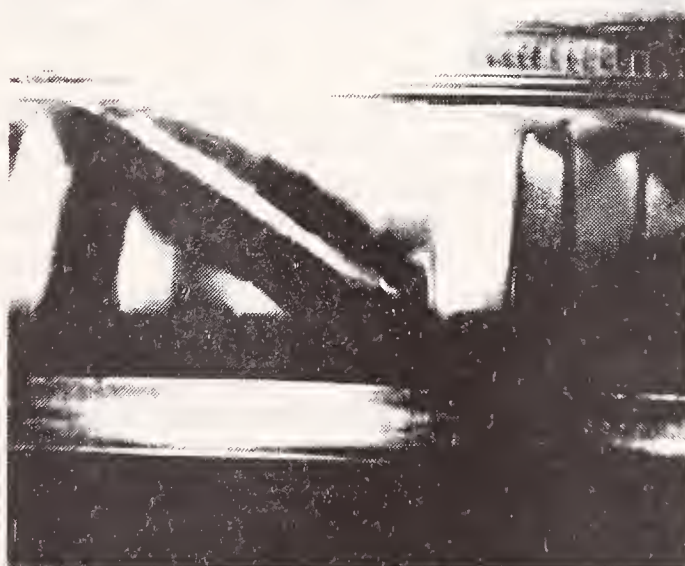
Figure 21a. Diagonal wrinkle in transducer stainless steel sheath.

Figure 21b. Diagonal wrinkle in transducer stainless steel sheath.

Figure 21c. Diagonal wrinkle in transducer stainless steel sheath.

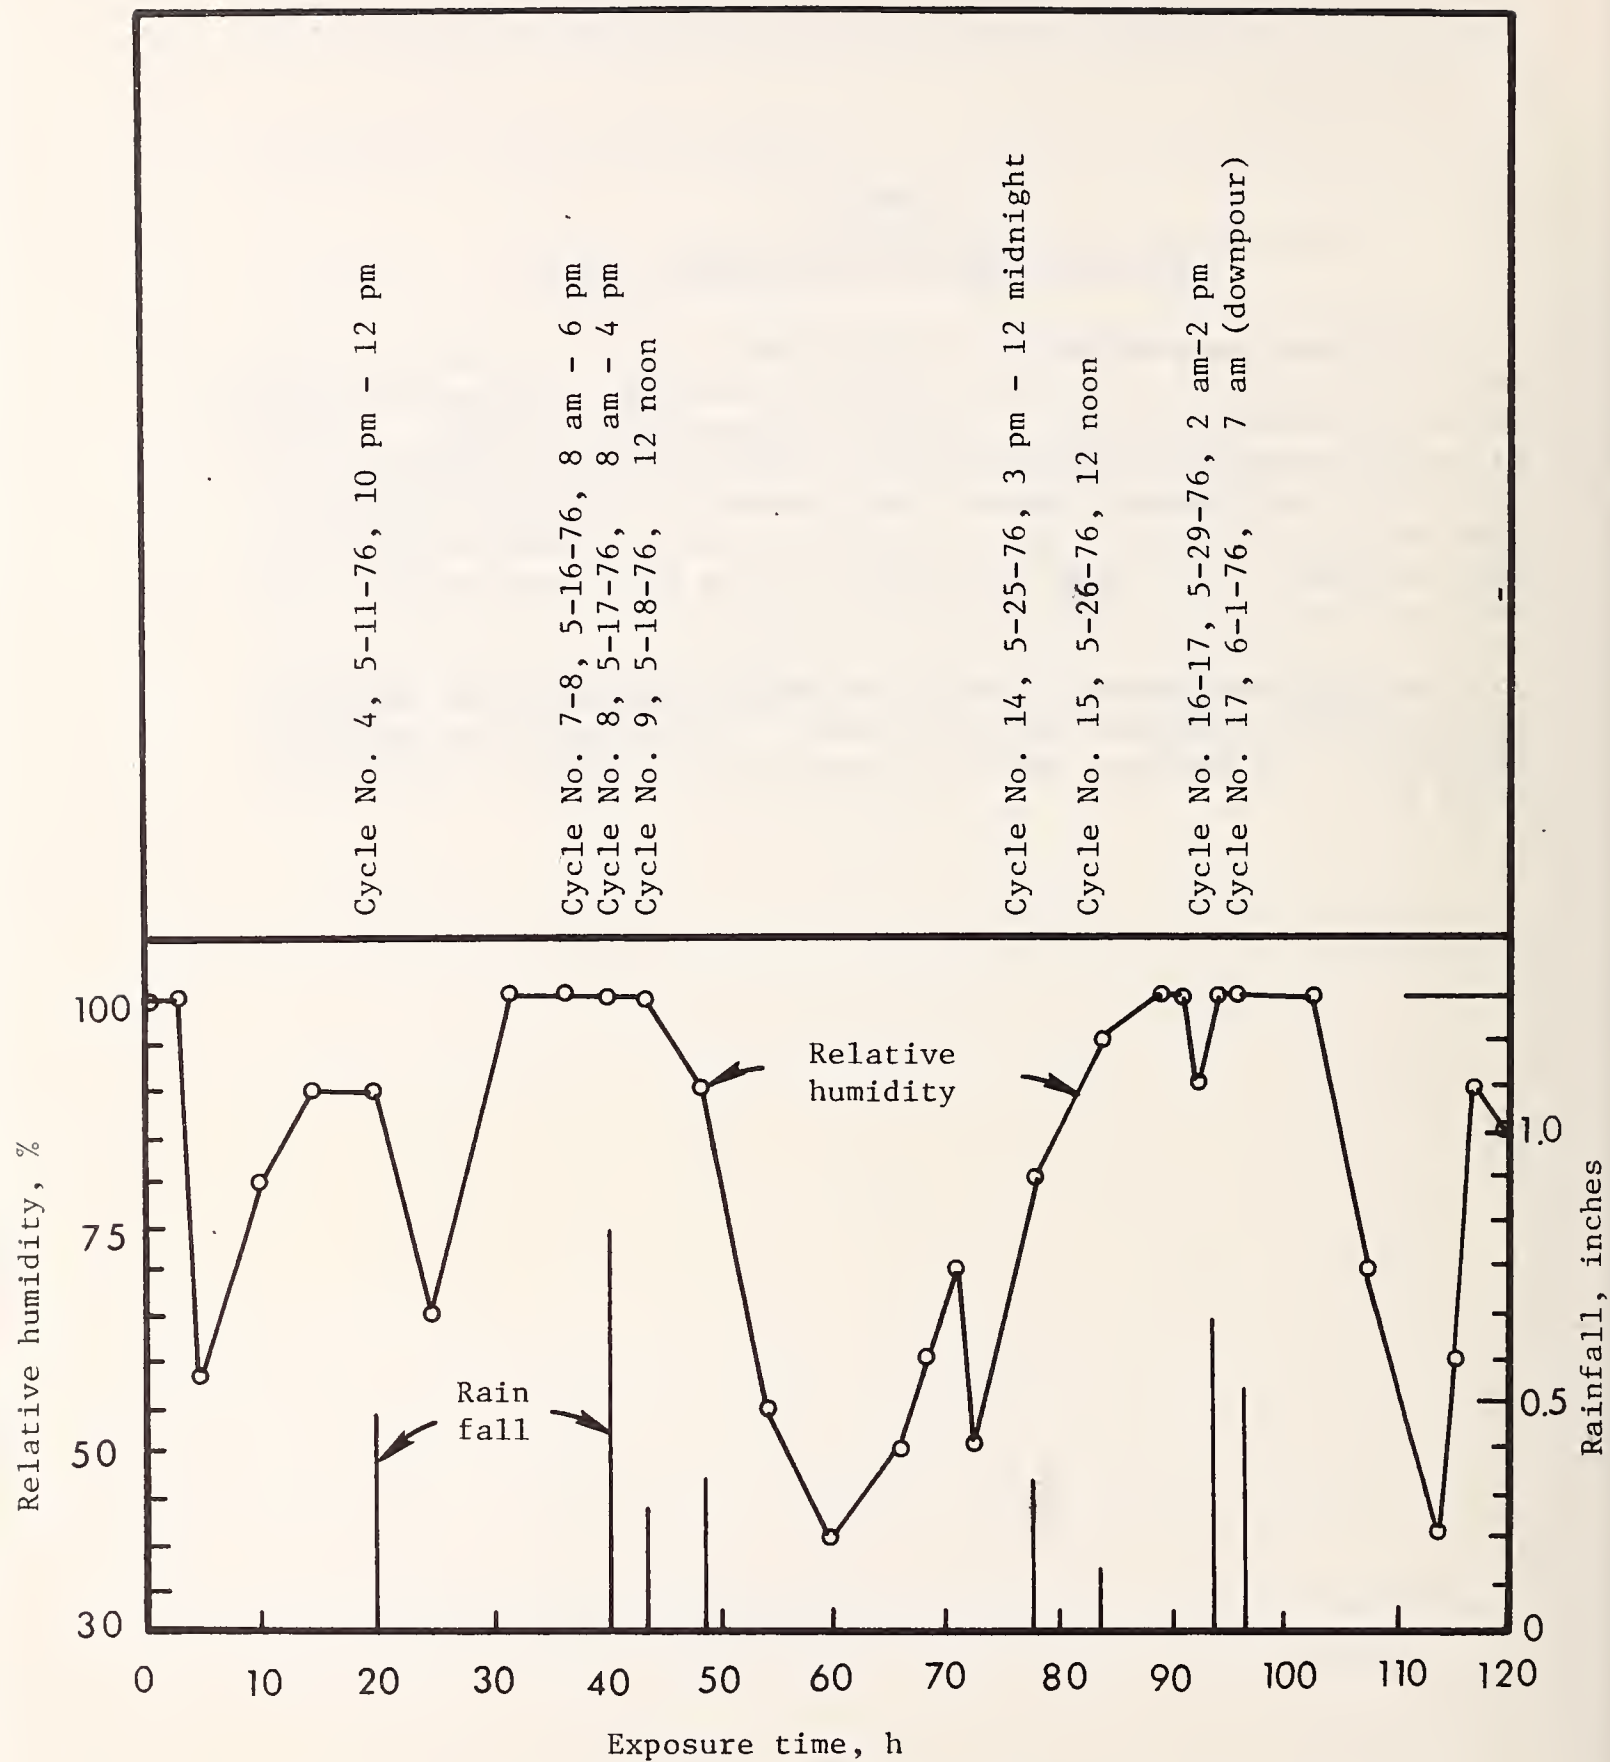
The graphical data show both the relative humidity (in percent, using the left ordinate) and the rainfall (in inches, using the right ordinate). The abscissa gives the same exposure times as in Figures 2 and 3.

Figure A-1. Relative humidity and rainfall during testing period.

The relative humidity and rainfall data cover a period from April 30, 1976 through June 7, 1976. The data were obtained from the National Bureau of Standards Exposure Station, Gaithersburg, Maryland, maintained by the Materials and Composites Section (461.02), of the Structures, Materials, and Safety Division. The Exposure Station site was less than one-half mile from the location where the corrosive moisture tests were performed. The relative humidity values were measured at 8 a.m. daily.
